# **INCIDENT REPORT**

**INCIDNET SUMMARY:** Loss of critical power and cooling in Data Hall, L1-130 & L1-135

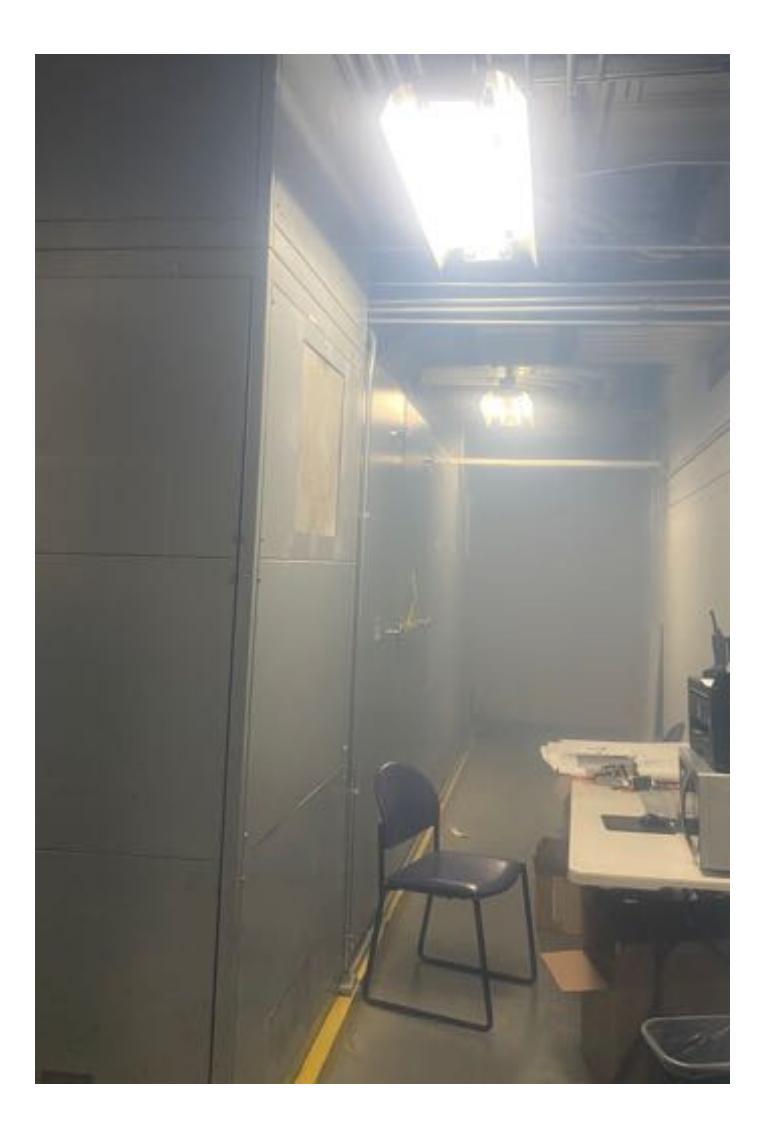
At approximately 3:45 PM, Building Engineering was alerted to a significant smoke alarm activation within the main switchgear room of our central plant (refer to the photo attached below). Our building engineers promptly responded to the alarm and commenced an investigation to determine the source of the smoke. However, we were able to confirm that all the power equipment in our main switch gear room shows no signs of burning or damage. We suspect that the smoke could originate from a secured door leading to the utility company's transformer fault located next to the main switch gear room which we have no access to.

At approximately 4:15 PM, after 45 minutes of investigation, we were able to reset the smoke alarm within the Building's Fire Life Safety (FLS) System, although the origin of the heavy smoke remained undetermined at that point. It is our assumption that it could originate from the secured door to the utility company's transformer fault located next to the main switch gear room which we have no access to.

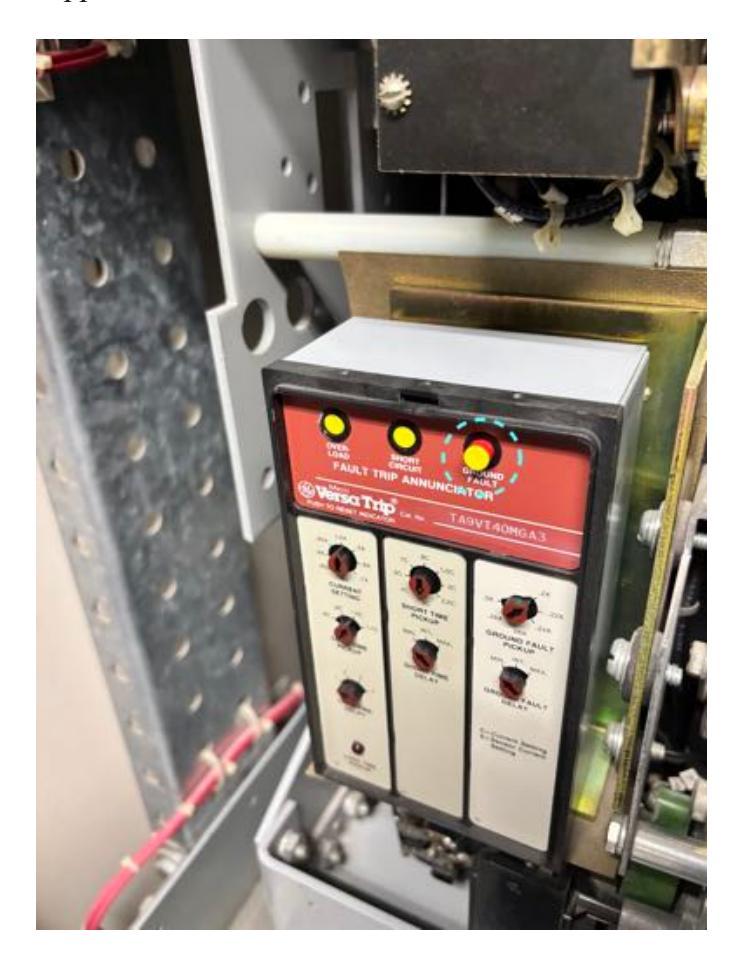
the recent outage—including the UPS systems, PDUs, RPPs, and circuit breakers, tracing from downstream to upstream throughout the entire power infrastructure—it has been determined that there are no apparent issues originating from the building equipment itself. See photo of the tripped Ground Fault Protection behind the 4000A breaker.

Based on the findings of this comprehensive assessment, we believe that the incident was likely caused by an intermittent ground fault originating from one or more pieces of electrically faulty equipment. This could include, but is not limited to, an in-rack PDU located within a cabinet in either L1-130 or L1-135. This intermittent ground fault adversely affected the UPS Static Bypass breaker, upstream 4000A utility power breaker and the generators' ability to provide stabilized back up power source, consequently causing the generator source to shut down by entering a "Lock-Out" condition.

Our engineering team is currently inspecting all customer-provided power equipment within the data halls of L1-130 and L1-135. During this process, we identified a faulty power distribution unit within a cabinet in L1-130, which may have been the source of the recent intermittent ground fault. This PDU was removed at 12:00 PM on May 14, 2025.

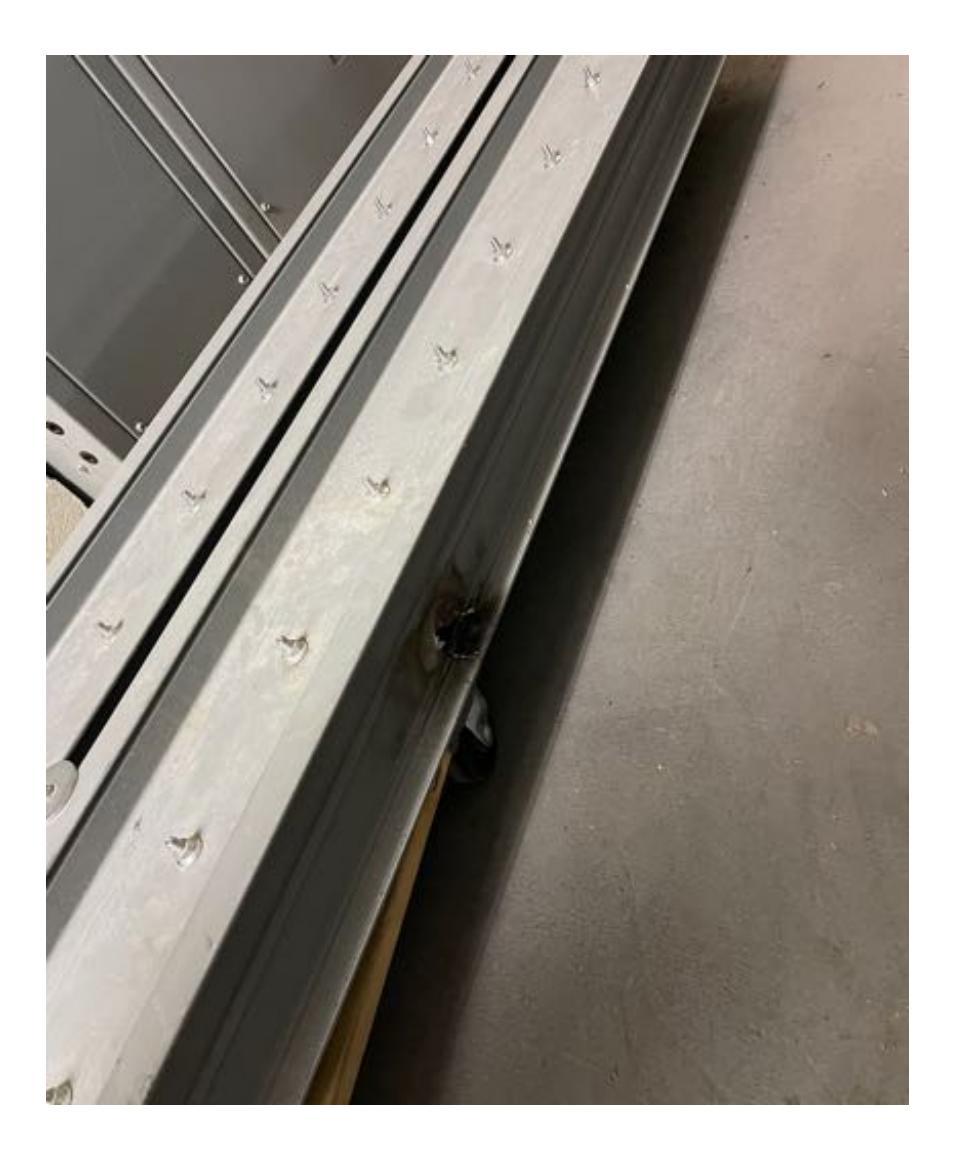
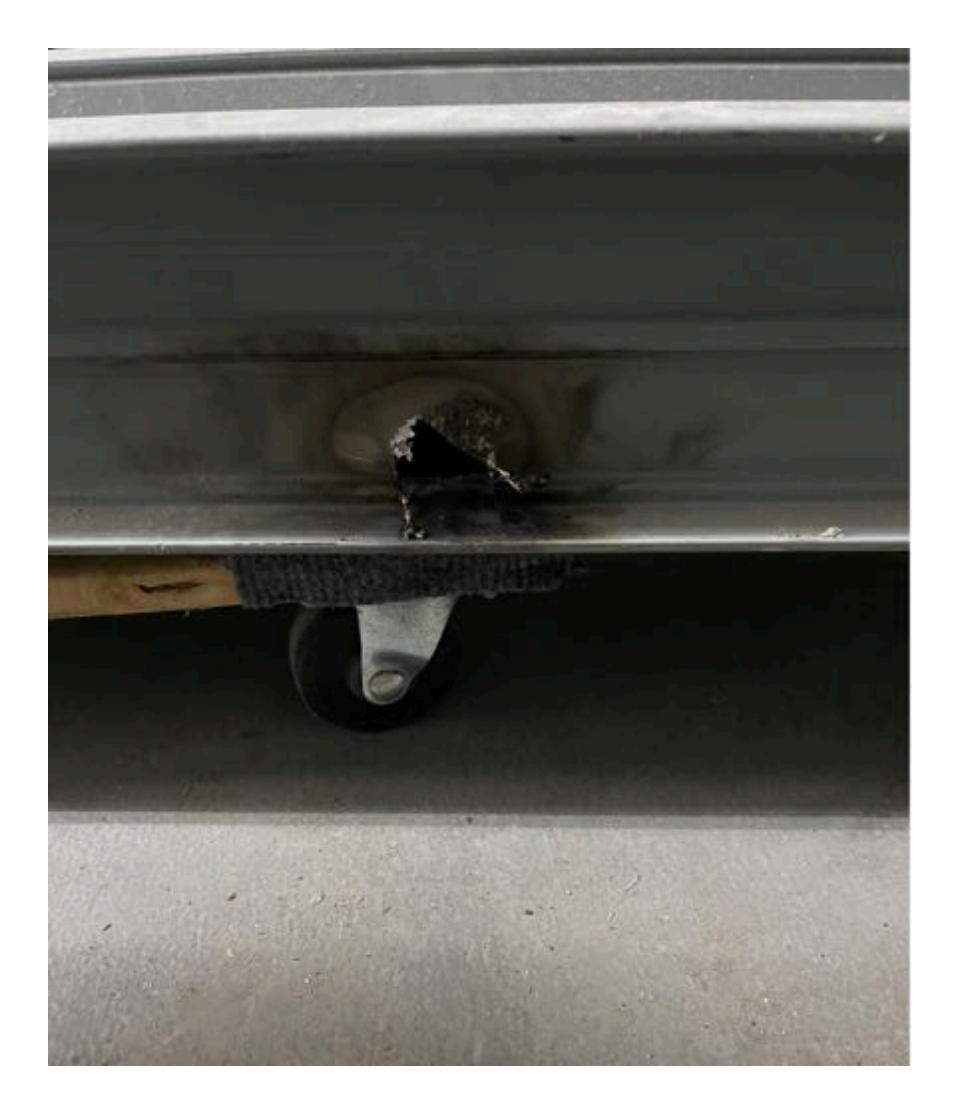
Based upon our subsequent investigation, it has been revealed that an arc flash occurred in the 4000A bus duct located in the ceiling of the main switchgear room caused by a ground fault condition initiated downstream from L1-130/135. This bus duct connected the utility feed from the main switchgear room to L1-130/135.

The arc flash had resulted in an explosion that created a puncture on the side of the 4000A bus duct. The puncture on the side of the bus duct was approximately six inches from the adjacent wall. As demonstrated in the attached photos below, this proximity to the wall made this finding difficult to be located during our earlier inspections.

On May 22, 2025, commencing at 7:00 am, a collaborative effort involving three engineering consultants, our preferred electrical team, and our internal engineering department successfully rerouted the 4000A feed to a backup utility source. Subsequently, the damaged bus duct was deenergized and replaced, and the system was fully operational by 2:30 pm. The emergency replacement procedures were completed without any interruption to service for our data center customers in L1-130/135. The replacement is a complete success. A photograph of the new bus duct following the replacement is attached for your review.

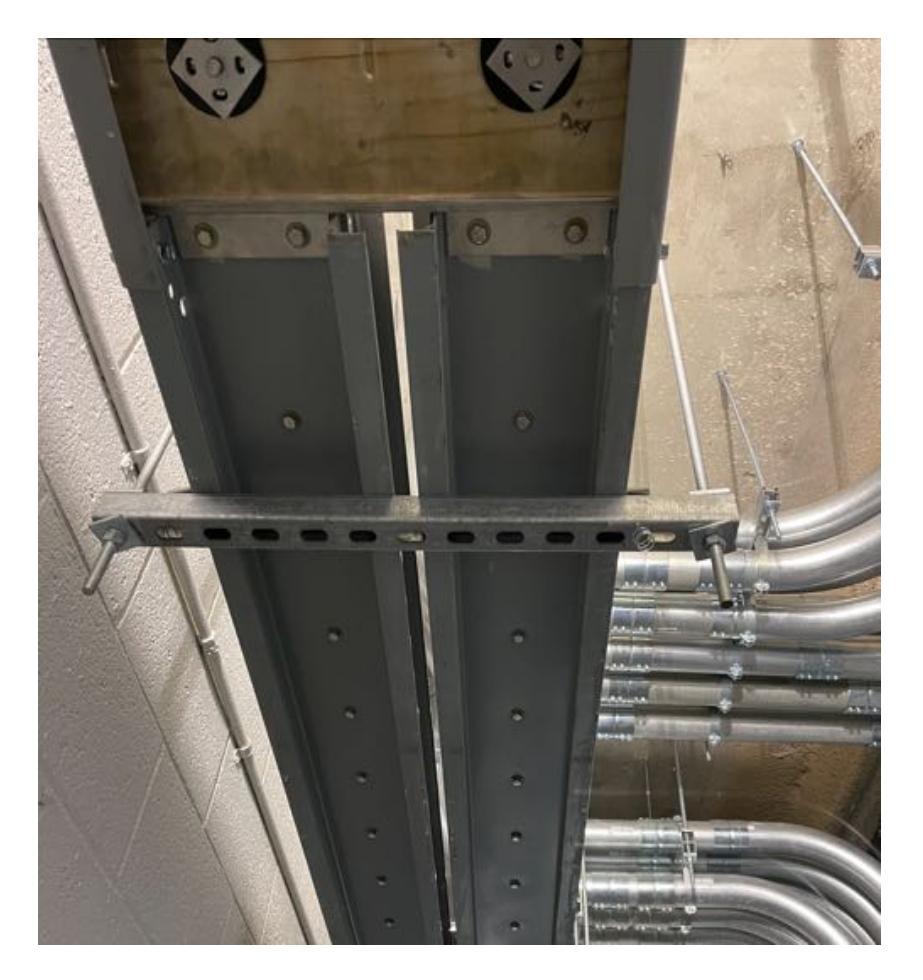
New Bus Duct after the emergency replacement
